METALS HANDBOOK

VOL. 9
FRACTOGRAPHY AND ATLAS OF FRACTOGRAPHY

8th EDITION

Fractography and Atlas of Fractographs

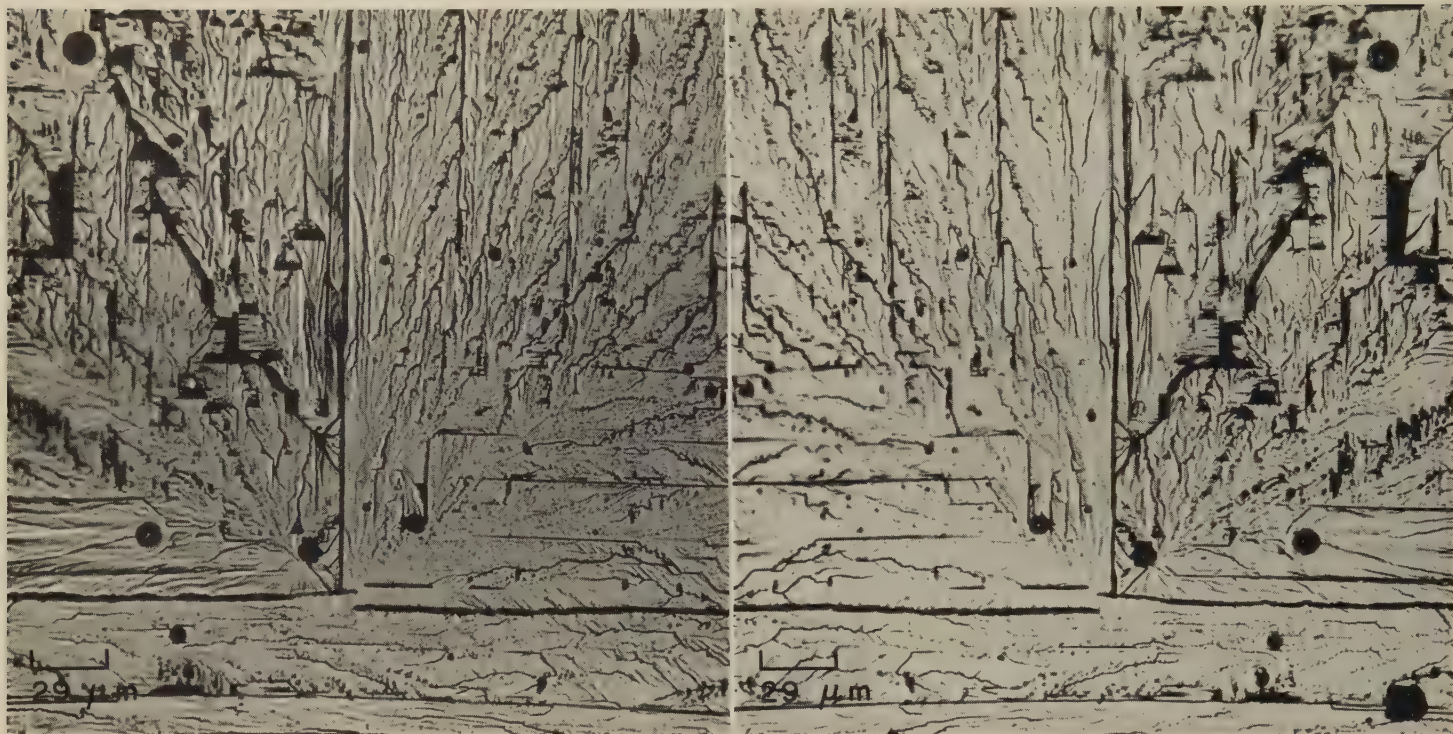
3477, 3478

Mating surfaces of a fracture in a ¼-in.-square specimen of Armco ingot iron cut from a hot rolled ¼-in.-thick plate, annealed at 1250 C (2282 F) for 2 hr, and furnace cooled. Hydrogen embrittlement was produced by cathodic treatment for 90 min in 10% H₂SO₄ at 90 C (194 F). The specimen was then notched and broken by impact at room temperature. These views show a portion of a single grain. The crack entered the area shown here at extreme left and right, near bottom. The cubic nature of the fracture pattern indicates that this is a (001) facet intersected by {112} twins. Gas holes (or inclusions) affect the fracture pattern locally.

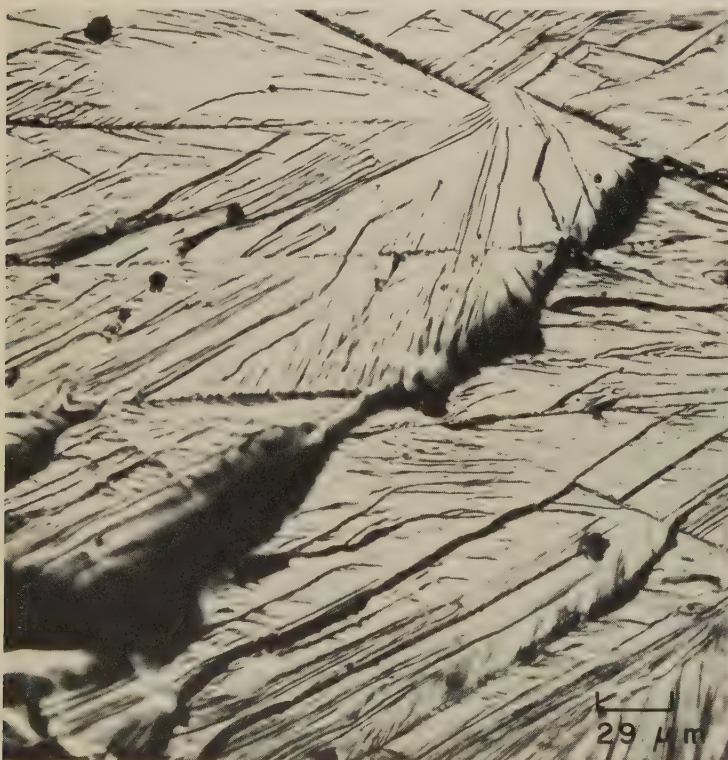
Fracture surface of a specimen of Armco ingot iron that was annealed at 1250 C (2282 F) for 2 hr and furnace cooled, then reduced 20% in thickness and broken by impact at room temperature. The primary cleavage fracture follows a (001) plane; the secondary traces are along {112} and {110} planes.

Fracture surface of a specimen of Armco ingot iron that received the same thermal and mechanical treatment given the specimen in 3479 (left), and then was cathodically hydrogen embrittled for 30 min in 10% H₂SO₄ at 90 C (194 F) and broken by impact at room temperature. The crack entered the area shown here at bottom center and produced a (001) facet that is much flatter than that shown in fractograph 3479.

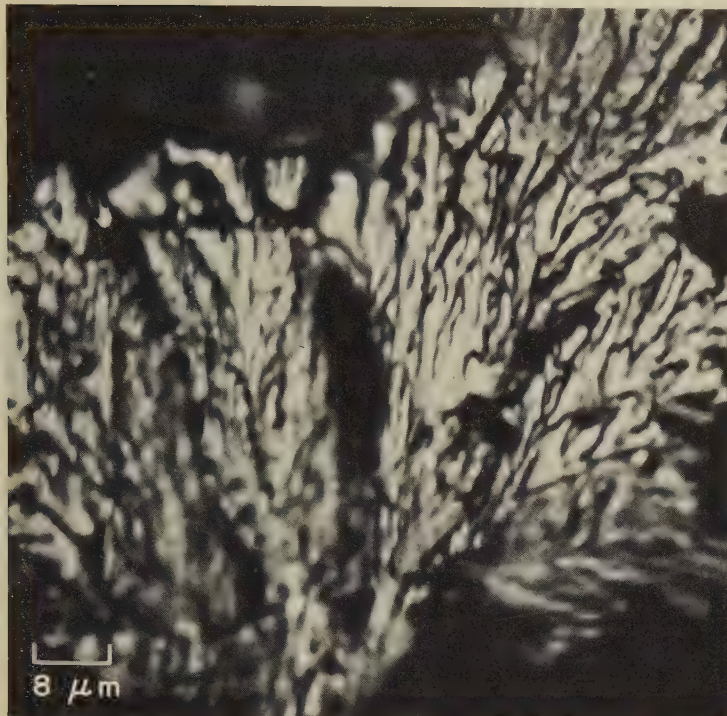
3481 Surface of a fracture in a specimen of ship-plate steel* (0.23% C, 1.09% Mn, 0.05% Si) that was water quenched from 868°C (1594°F), tempered 2 hr at 704°C (1300°F) and broken by impact at -196°C (-321°F). The coarse river patterns in this rough surface denote high "toughness". Compare with 3482 and 3483.

3482 Surface of a fracture in a specimen of as-rolled ship-plate steel* (0.17% C, 0.81% Mn, 0.16% Si; fully killed) that was broken by impact at -196°C (-321°F). The crack entered at lower right here and generated a facet much flatter than that in 3481, but left very distinct fracture-progress markings.

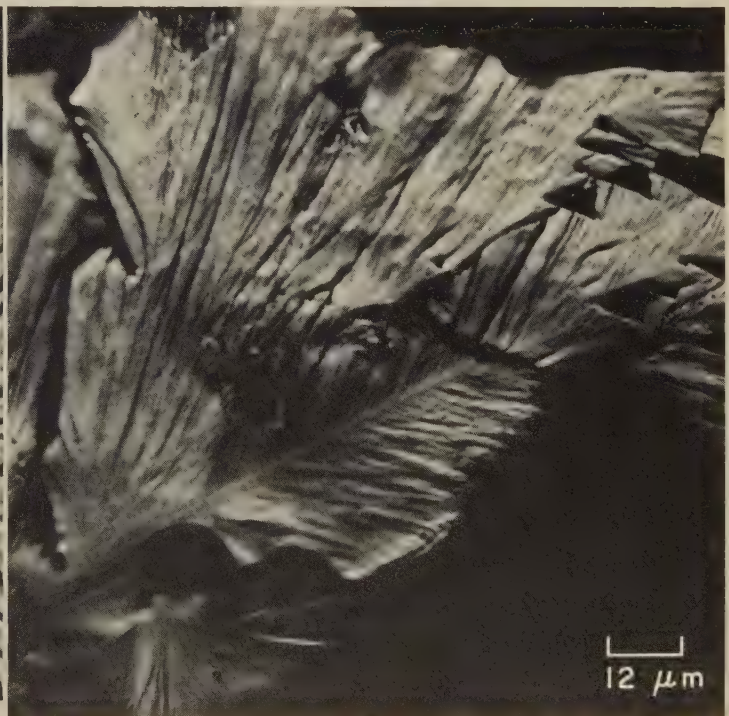
3483 Surface of a fracture in a specimen of as-rolled ship-plate steel* (0.22% C, 0.37% Mn, 0.009% Si; rimmed) that was broken by a hammer blow at -196°C (-321°F) after being stored for 4 months. This flat facet, which is typical of brittle fractures, shows intersections by {112} twins. See also fractograph 3484.

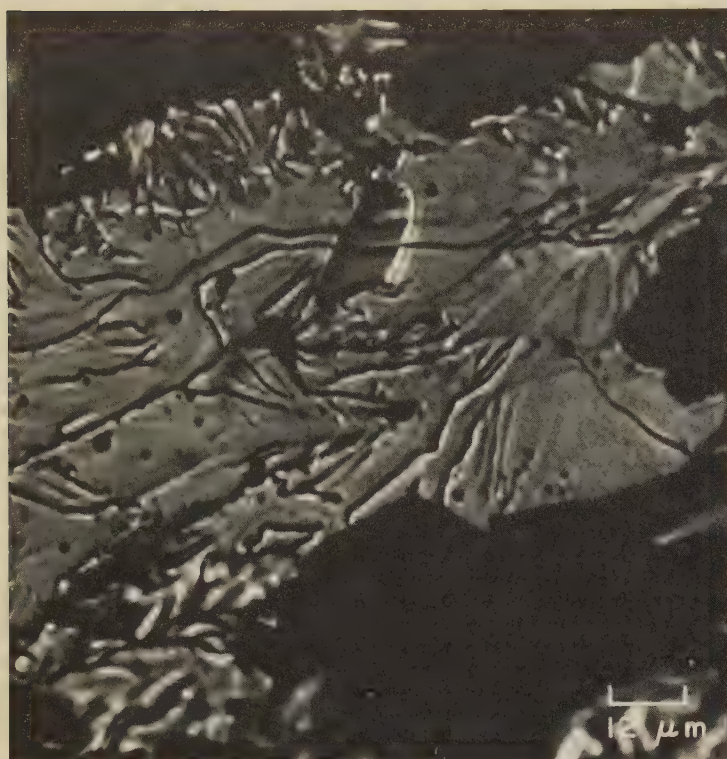
Light fractograph

3485 Fracture surface of a carbon steel weld deposit broken by impact at -196°C (-321°F). The deposit was in a 90° T-joint of $\frac{1}{4}$ -in.-thick plate fillet welded with a $\frac{5}{32}$ -in.-diam E6010 electrode in a single pass using direct current. This brittle cleavage facet resulted from hydrogen pickup during deposition from the cellulosic covering of the E6010 electrode. See 3486-3488.

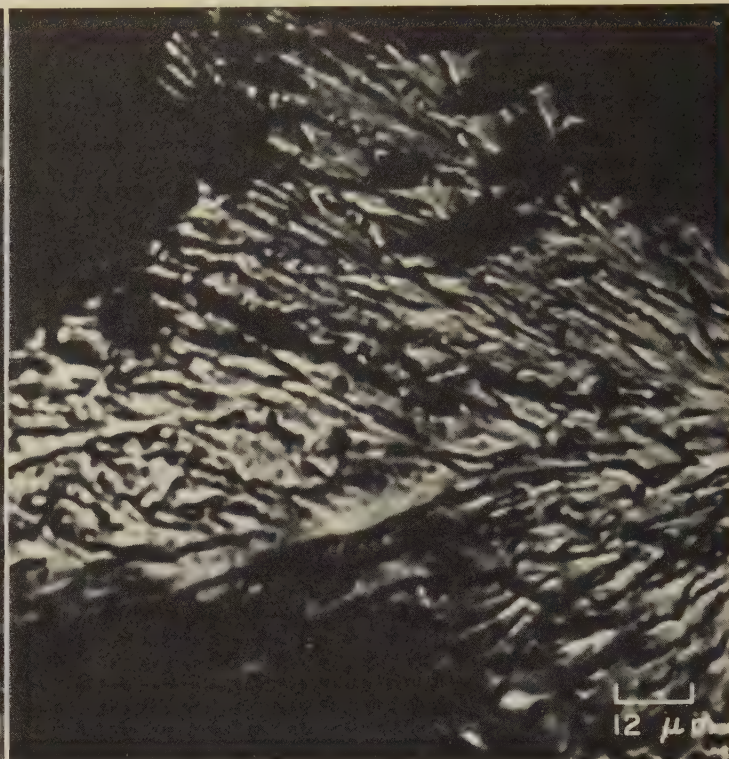
Light fractograph

3486 Fracture surface of a carbon steel weld deposit produced, and impact tested, under the same conditions as for 3485 except for the use of fully dried low-hydrogen E6015 covered electrodes. The rough surface with coarse river patterns, which is characteristic of "toughness", is similar to that in 3481 (preceding page). See also fractographs 3487 and 3488, below.

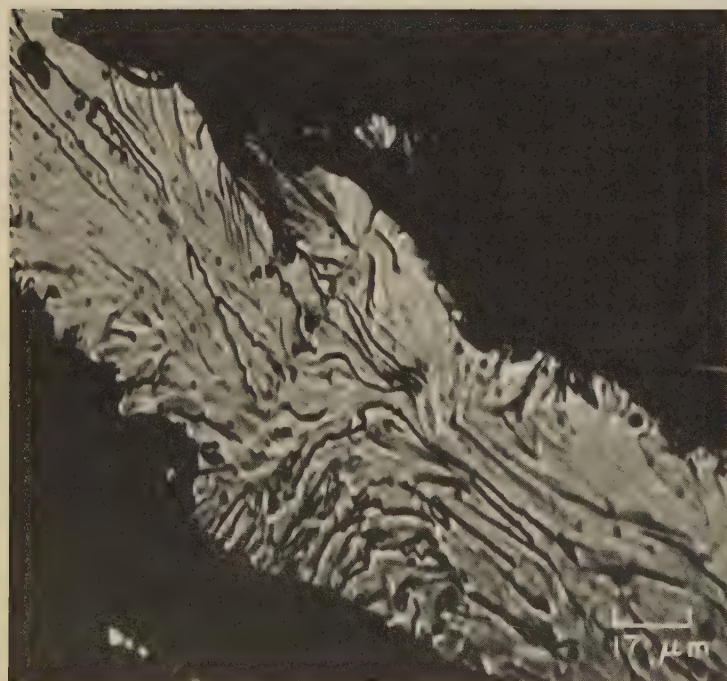
Light fractograph

3487 Fracture surface of a weld deposit made under the same conditions as for 3486 except the E6015 electrodes were inadequately dried, by being held 1 hr at 149°C (300°F) rather than the recommended 315°C (600°F), which failed to eliminate hydrogen from the covering. Result was a brittle fracture, as typified by this flat facet (which is like 3485). See 3488.

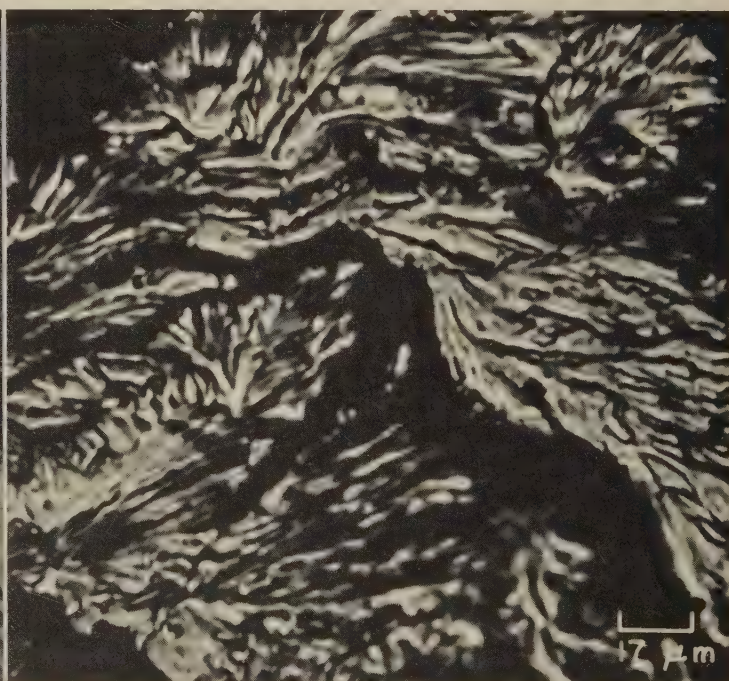
Light fractograph

3488 Fracture surface of a deposit from the same fillet weld as the one that provided the specimen in 3487, but taken from the last portion of the bead. The resemblance of the facet to that in fractograph 3486 indicates that the heat given off by the arc had dried the electrode covering before the final portion of the weld bead was laid down, eliminating the earlier brittleness.

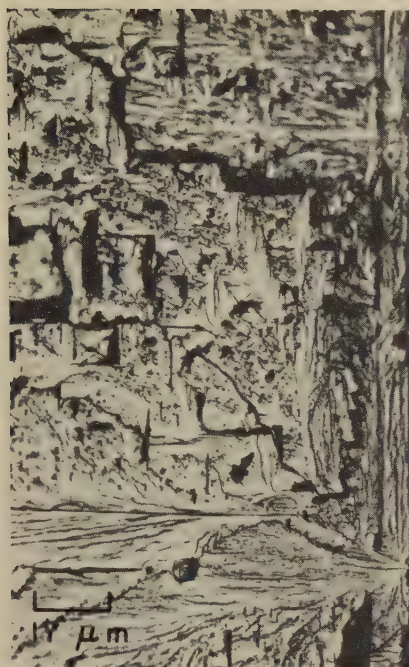
Light fractograph 600×
3489 Fracture surface in a decarburized zone of type 405 stainless steel. Cleavage crack with cubic symmetry entered zone from lower right. See also 3490.

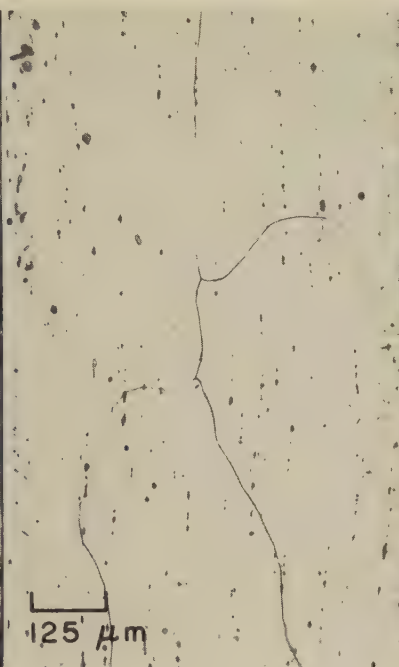
Micrograph (HCl and picric acid) 80×
3490 A polished and etched section through the specimen in 3489, displaying the large grains that resulted from a prolonged decarburizing treatment.

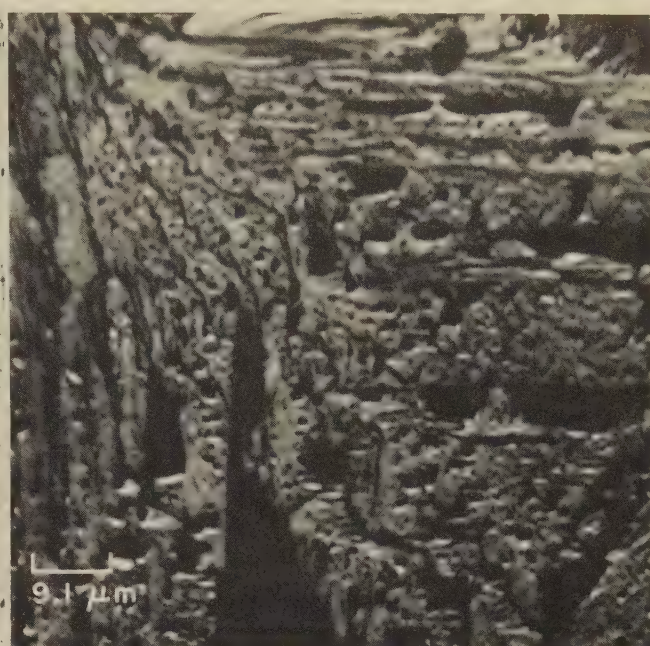
Light fractograph 1100×
3491 Impact-fracture surface of a notched specimen of type 430 stainless steel that was heated for 3 hr at 1050 C (1922 F) and furnace cooled, then broken at room temperature. A blocklike pattern of brittle cleavage on a (001) facet. This is typical of fractures in chromium ferrite, for temperatures as low as -196 C (-321 F).

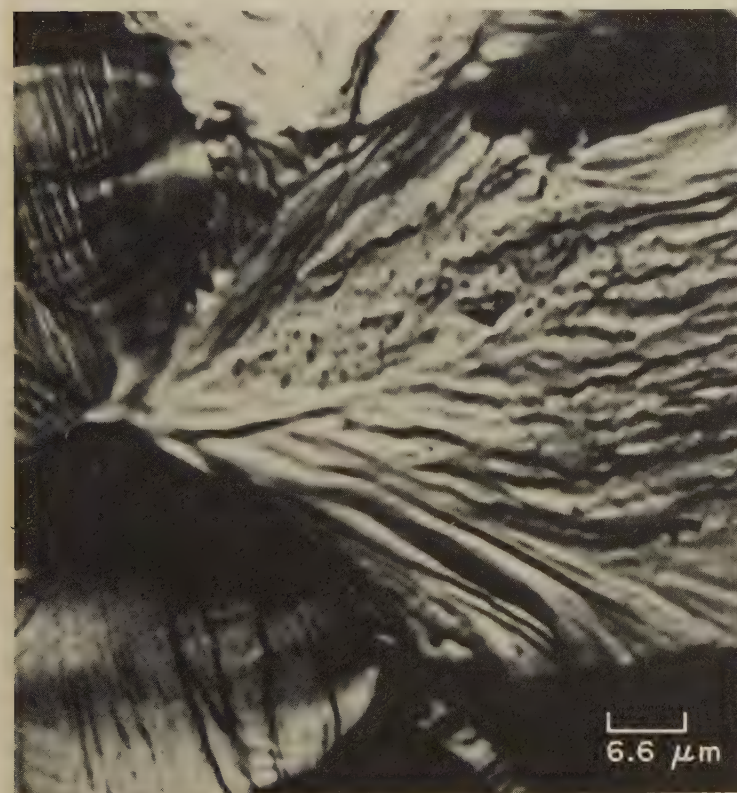
Light fractograph 1525×
3492 Impact-fracture surface of a notched specimen of type 430 stainless steel that was heat treated the same as the specimen in fractograph 3491, but was broken at 100 C (212 F). The blocklike pattern of brittle cleavage visible in 3491 is not exhibited here, and this facet conforms less closely to the expected (001) plane; both indicate decreased brittleness.

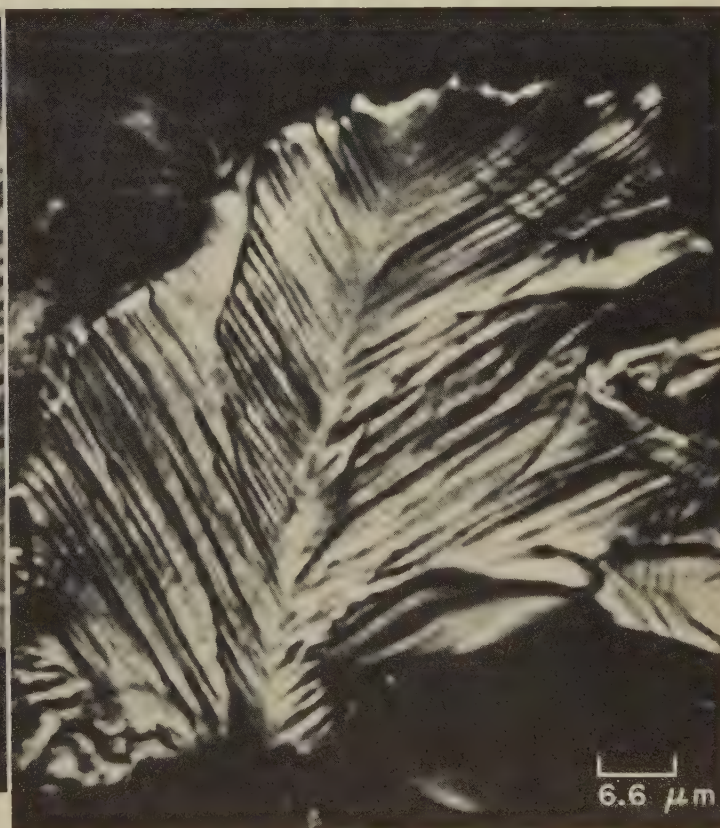
Light fractograph 1525×
3493 Fracture surface of a specimen of type 430 stainless steel with the same heat treatment as specimens in 3491 and 3492, but broken by a hammer blow at 200 C (392 F). The spine separates orthogonal markings.

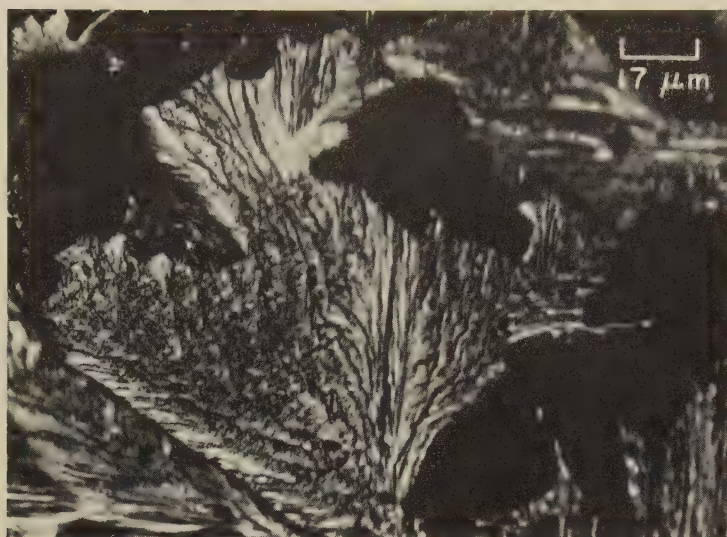
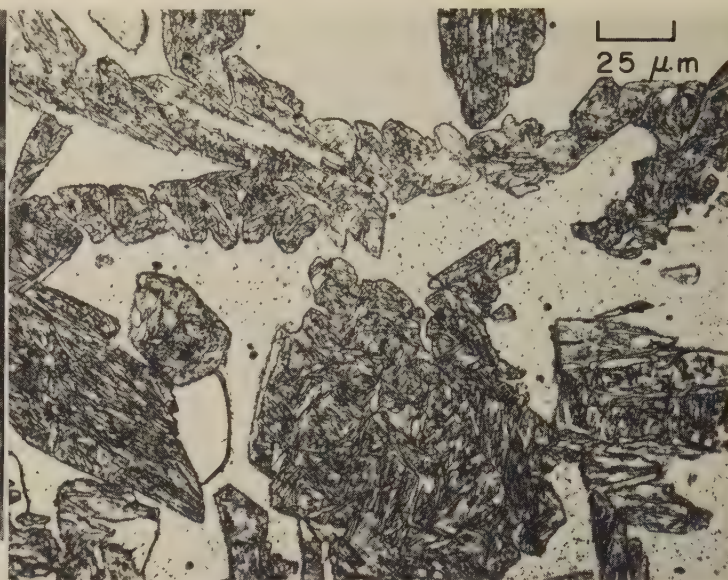
3494 Surface of an impact fracture in type 430 stainless steel (0.103% C, 17.16% Cr) cast as a 5-lb laboratory heat, forged to a 1-in.-square bar, heat treated ¼ hr at 982 C (1800 F), oil quenched, then broken at room temperature. River patterns are visible on facets of ferrite grains. Dark areas are martensite regions that were circumvented by the crack. See also 3495.

3495 Polished-and-etched section through the type 430 stainless steel specimen shown in fractograph 3494 (at left). In contrast to 3494, here the acicular structure of the martensite (dark-etching areas) is visible and ferrite (light-etching) is structureless.

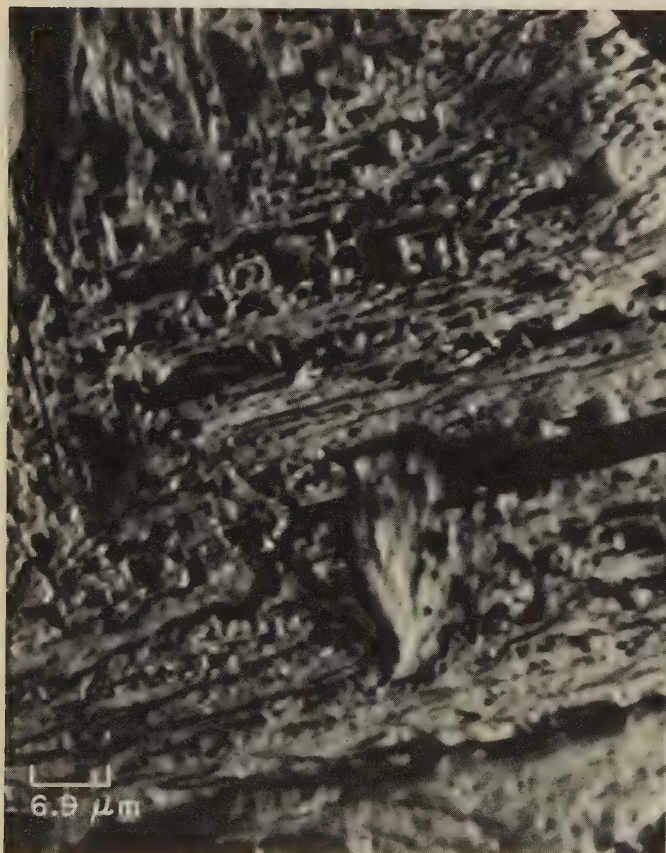
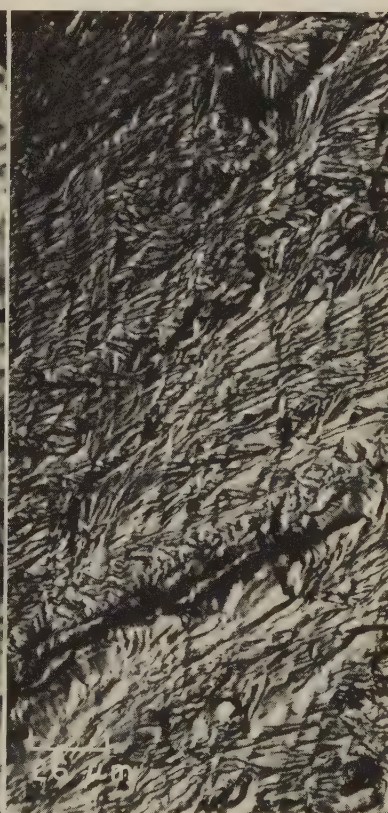
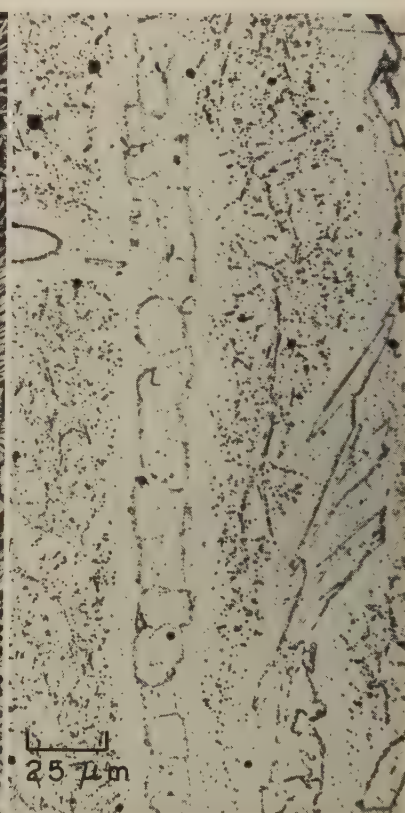
3496 Surface of an impact fracture in a specimen of type 430 stainless steel (0.061% C, 0.45% Mn, 0.37% Si, 16.9% Cr) annealed at 1052 C (1926 F) for 3 hr, furnace cooled, then broken at room temperature. Crack front entered this region at lower left. Shown is a portion of a (001) facet, presenting a blocklike pattern with cubic symmetry, similar to the pattern shown in fractograph 3491.

3497 Impact-fracture surface in 0.096C-22.14Cr ferritic stainless steel cast and forged as in 3494, annealed at 871 C (1600 F), oil quenched from 982 C (1800 F), broken at room temperature. Crack propagation was from left to right. This appears to be a cleavage fracture. See also 3498.

3498 A polished-and-etched section through the specimen in 3497. In contrast to 3495 (type 430 stainless), there is no martensite visible here, and the entire field consists of chromium-iron ferrite outlined by carbides precipitated during heat treatment. Relatively few inclusions are present.

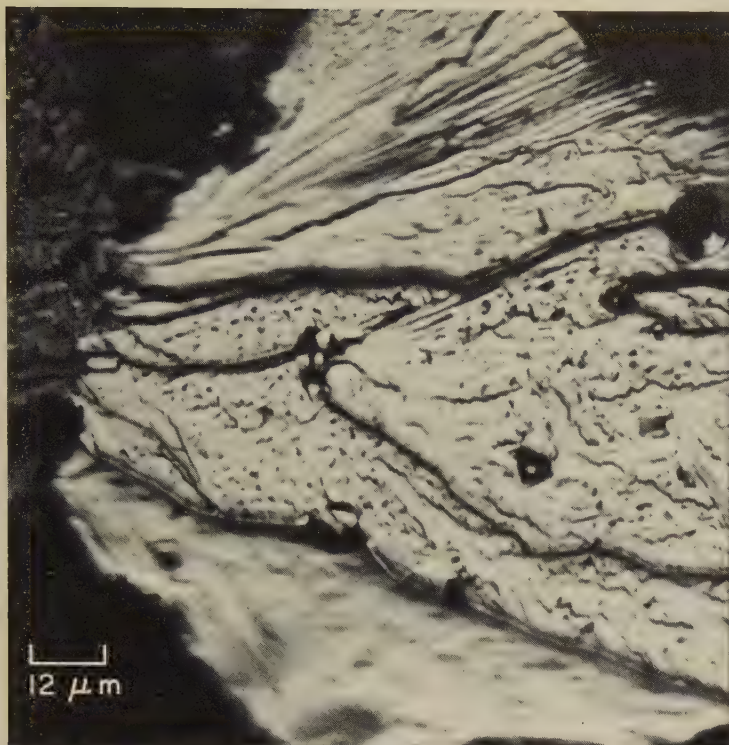
3499 Surface of an impact fracture in a specimen of type 446 stainless steel (0.145% C, 25.99% Cr) that was heat treated at 1150 C (2102 F) for 2½ hr and furnace cooled, then broken by a hammer blow at 200 C (392 F). Although no blocklike pattern is visible here, this fracture facet is still flat enough to indicate brittleness. See also fractographs 3500 to 3502.

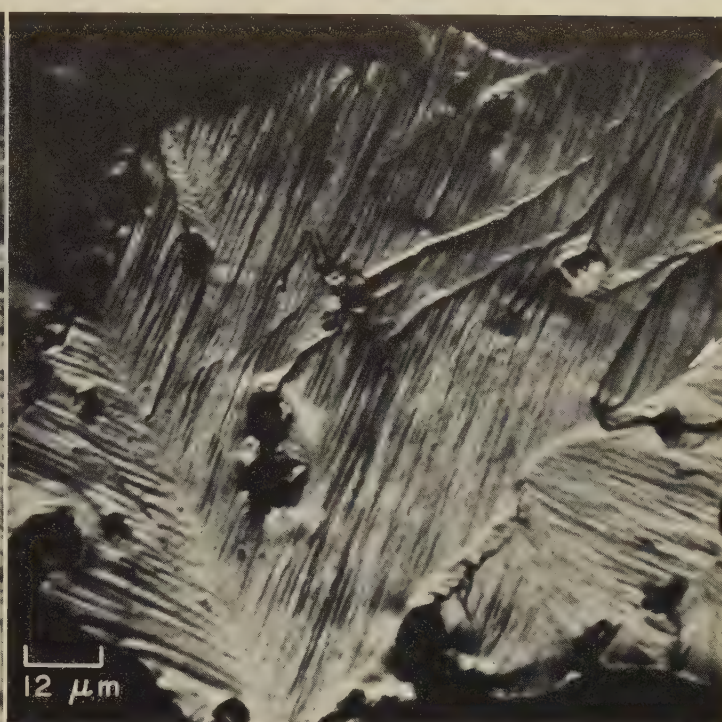
3500 Surface of an impact fracture in a specimen of the same stainless steel and heat treatment as in 3499, but broken by a hammer blow at 350 C (662 F). Note the similarity of this fracture to the ship-plate fracture at 35 C (95 F) in 3484, which shows the same spine structure with 45° and 90° symmetry. Arrowhead at center of right edge points to a diagonal boundary, which is believed to denote the meeting of two crack fronts.

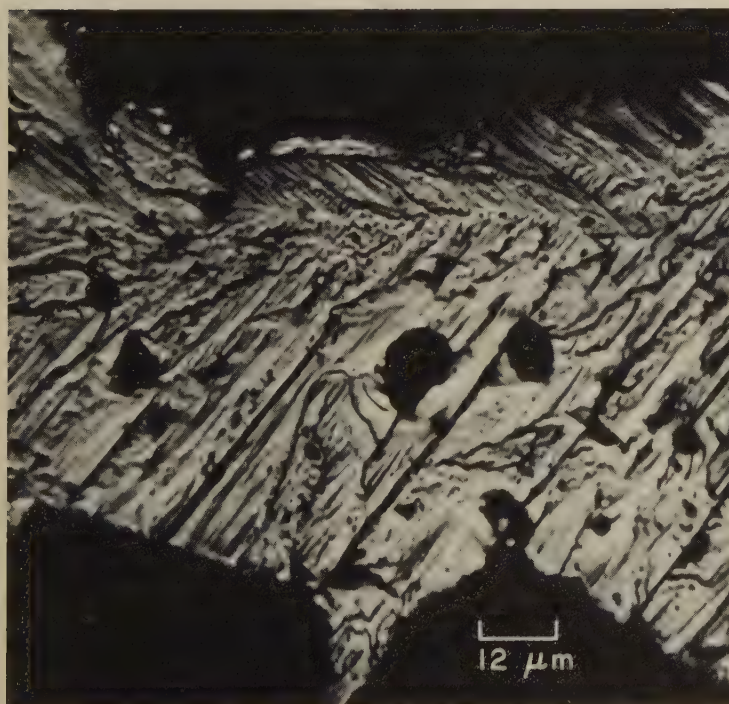
3501 Fracture surface of a specimen of the same stainless steel and heat treatment as in 3499 and 3500, broken at 350 C (662 F) by the impact of a 0.22-caliber rifle bullet fired at a range of 24 in. The facet resulting from this combination of impact velocity and test temperature resembles one produced by a hammer blow at 35 C (95 F) in the same material.

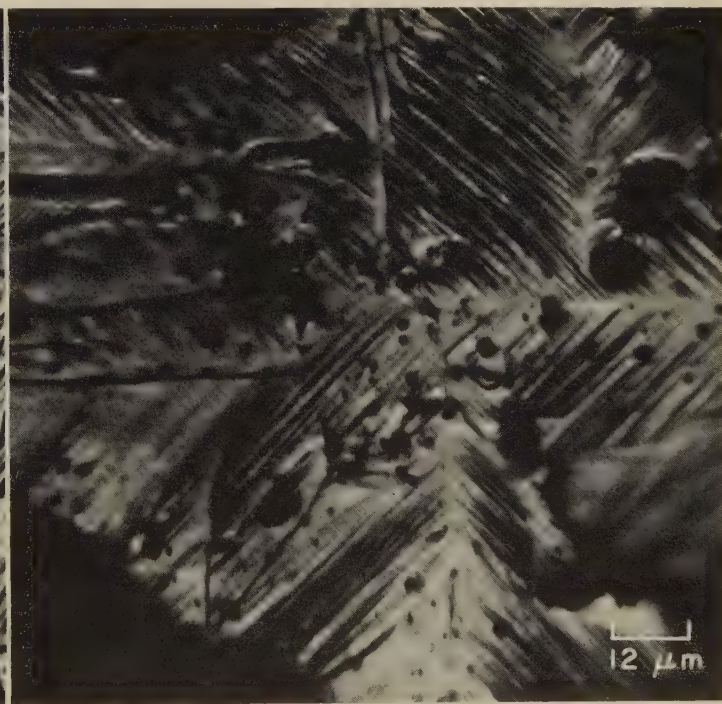
3502 Fracture surface of a specimen of the same stainless steel and heat treatment as in 3499, 3500 and 3501, broken at 475 C (887 F) by the impact of a 0.22-caliber rifle bullet. This facet, when compared with that in 3500, suggests that the higher testing temperature and the higher impact velocity had a net combined effect that yielded a fracture of similar brittleness.

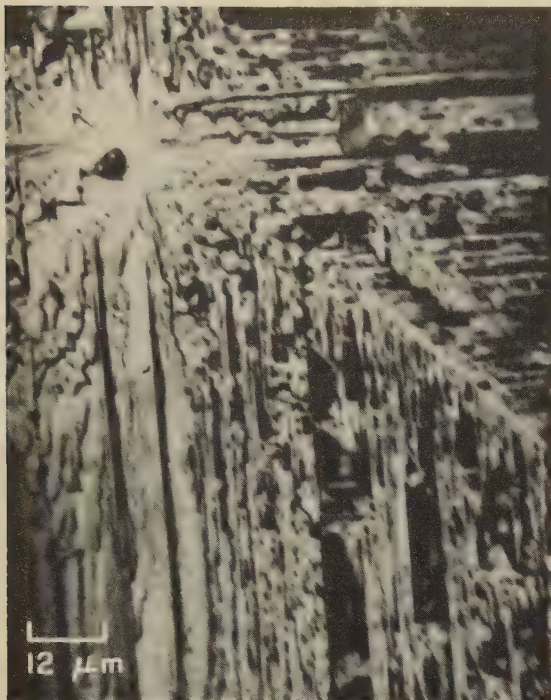
3503 Surface of an impact fracture in a specimen of type 446 stainless steel (0.10% C, 26.10% Cr) that was forged, heat treated 40 hr at 871 C (1600 F), furnace cooled, annealed 2½ hr at 1150 C (2102 F), furnace cooled, then broken at room temperature. Crack front entered this grain at top left, producing fracture along a (001) facet. See 3504.

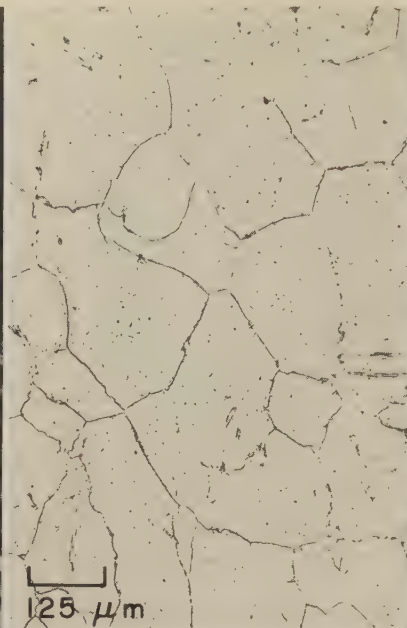
Micrograph (mixed acids in glycerol) 80×

3504 A polished-and-etched section through the specimen of 446 stainless steel shown in fractograph 3503 (left), revealing coarse-grained chromium-iron ferrite containing carbide particles and inclusions. Grain growth occurred during the high-temperature anneal at 1150 C (2102 F) that was used to ensure a cleavage fracture.

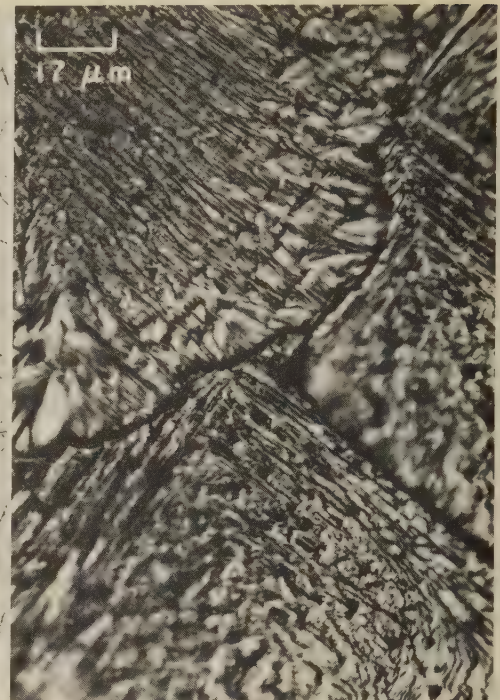
3505 Surface of an impact fracture in a specimen of type 446 stainless steel (0.107% C, 28.67% Cr) that was prepared as a 5-lb laboratory casting, forged, extensively recrystallized at 871 C (1600 F) for 40 hr, air cooled, then broken by a hammer blow at room temperature.

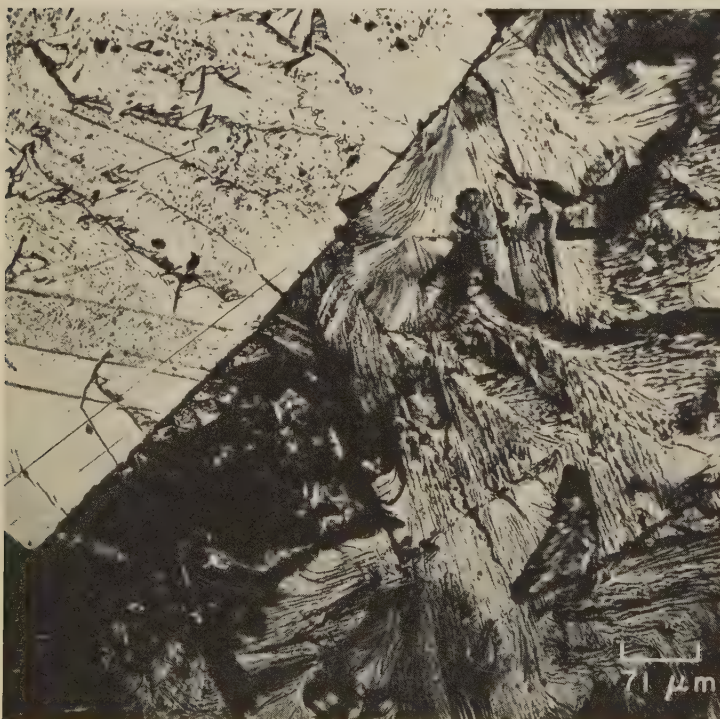
3506 Surface of an impact fracture in low-carbon ferrochromium alloy (0.05% C, 70% Cr) broken at room temperature. The crack front entered this area from the left. The light region left of the sharp diagonal boundary is a cleavage facet on a (112) plane; the darker region to the right of the boundary is an area of less-perfect cleavage showing river patterns.

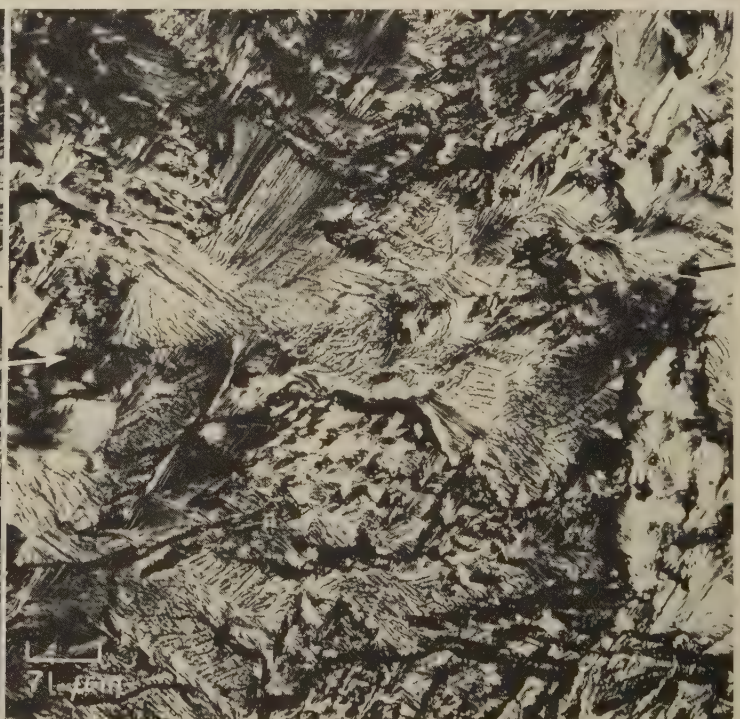
3507 Surface of an impact fracture in high-nitrogen ferrochromium alloy (0.75% N) broken at room temperature, showing elaborate fracture pattern. Two crack fronts entered this area, at upper left and at lower left, and met at the thin discontinuity at arrows, which may be a grain boundary. Note the closely matching, nearly opposite patterns.

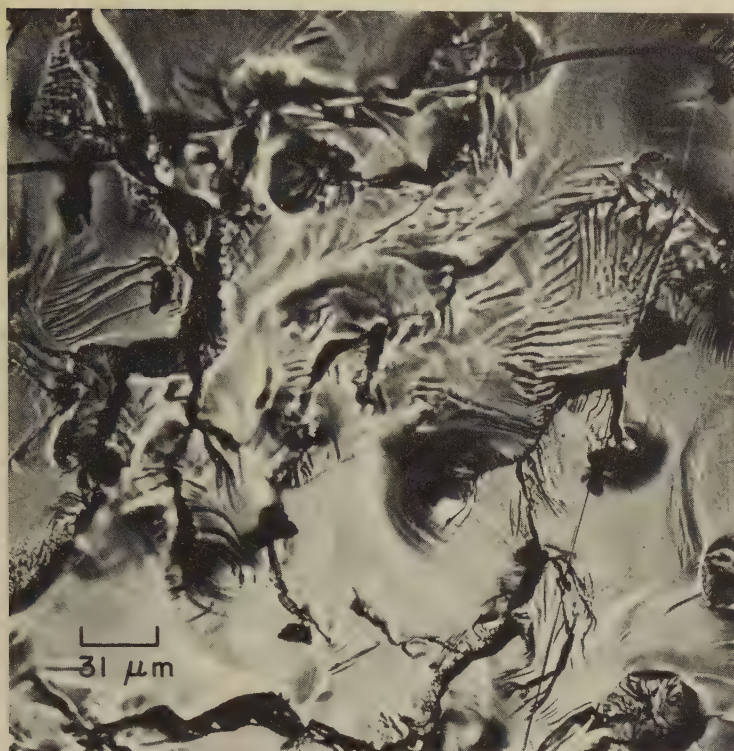
3508 Surface of an impact fracture in a specimen of commercial ferrochromium alloy (0.17% C, 70% Cr) that was broken at room temperature. This unusually smooth surface resembles the "glassy" fractures observed in very brittle materials and is believed to be a facet of a carbide particle. See 3509.

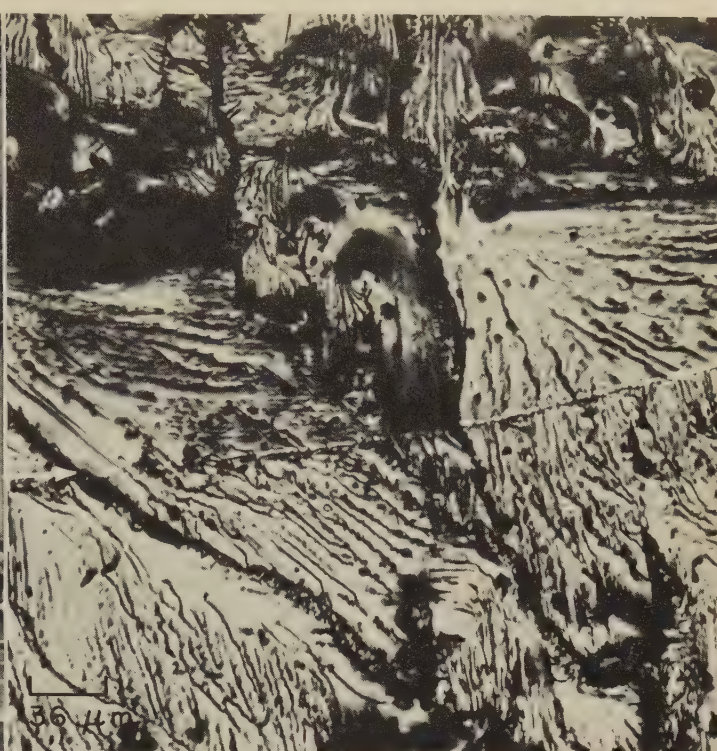
3509 A different area of the impact-fracture surface in 3508, showing mainly the river patterns expected in cleavage facets of grains of solid solution. Crack front entered this area from top left; crack propagation was only slightly affected by the transecting boundary (possibly a grain boundary) at arrows.

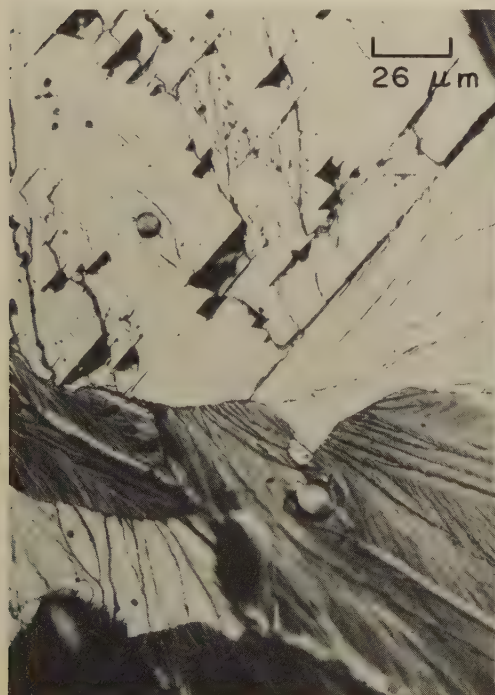
3510 Surface of an impact fracture in a specimen of an as-cast iron-silicon alloy (0.034% C, 1.59% Si) that was broken at room temperature. Crack front entered this area from the top as cleavage and changed to less-perfect cleavage with river patterns at boundary at midheight.

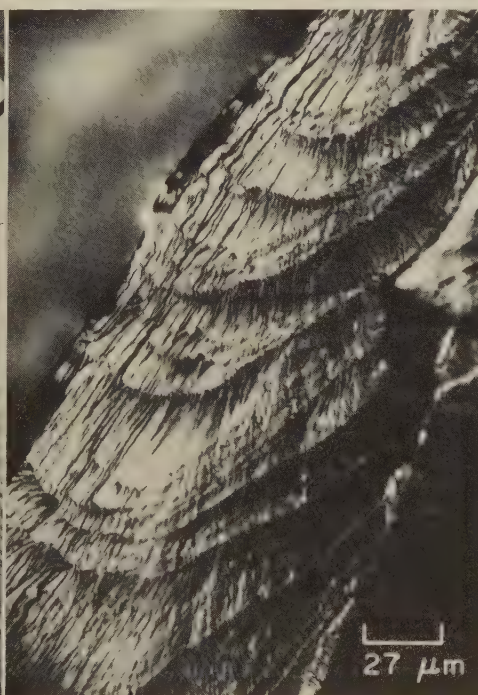
3511 Impact-fracture surface of a specimen of an as-cast iron-silicon alloy (0.038% C, 4.24% Si) prepared as a 5-lb laboratory casting and broken at room temperature. The fracture entered from top right. The interruptions in crack propagation suggest stress pulsations. See 3512.

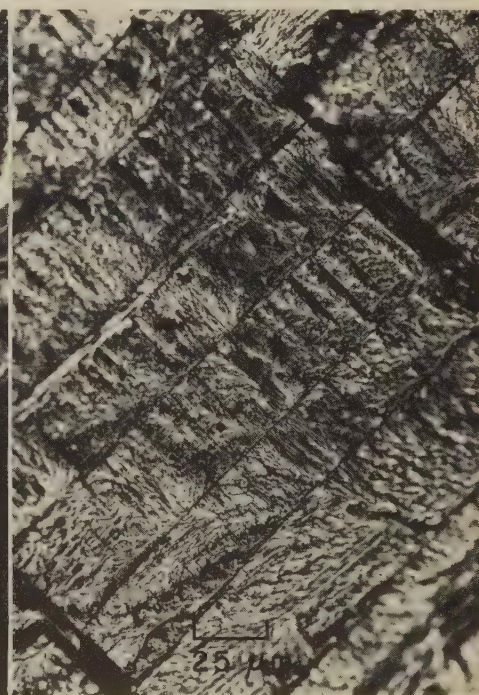
3512 Impact fracture in a specimen of same as-cast Fe-Si alloy as in 3511, also broken at room temperature, showing a portion of a single grain containing cell-like units bounded by intersections of the fracture surface by {112} twins (each cell contains its own river patterns). See 3513.

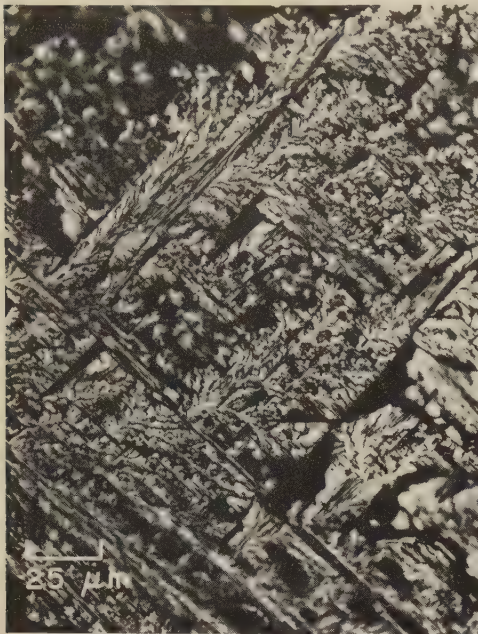
Light fractograph 400×
3513 Surface of an impact fracture in a specimen of the same as-cast iron-silicon alloy (0.038% C, 4.24% Si) as in 3511, 3512 (preceding page), also broken at room temperature, showing cubic symmetry with {112} Neumann bands (twins).

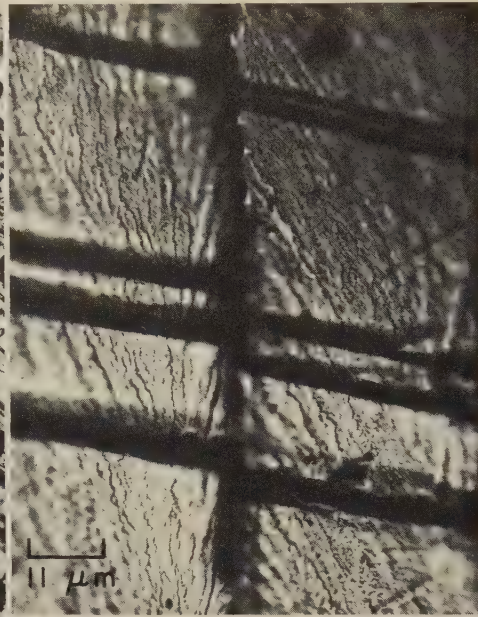
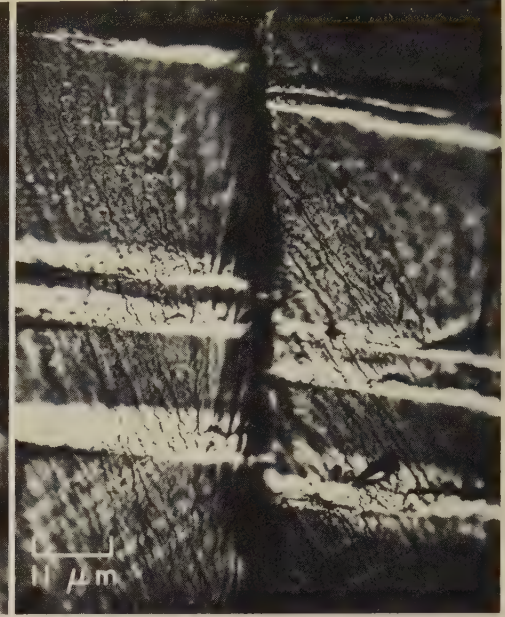
3514, 3515

Two obliquely illuminated views of the same facet in the surface of an impact fracture in an iron-silicon alloy (0.042% C, 4.96% Si) cast as an ingot 12 by 12 by 36 in., cooled under hot slag. This facet exhibits mechanical twins (Neumann bands), the sloping surfaces of which are in shadow in 3514 (left), with illumination from below, and are highlighted in 3515 (right), with illumination from above, illustrating the differences in surface level that are caused by twinning. The river patterns on this facet are uninterrupted by the twins.

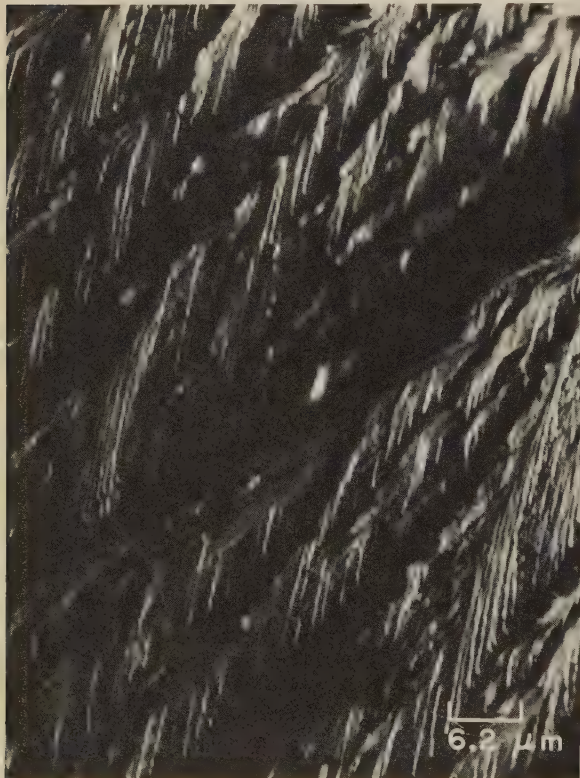
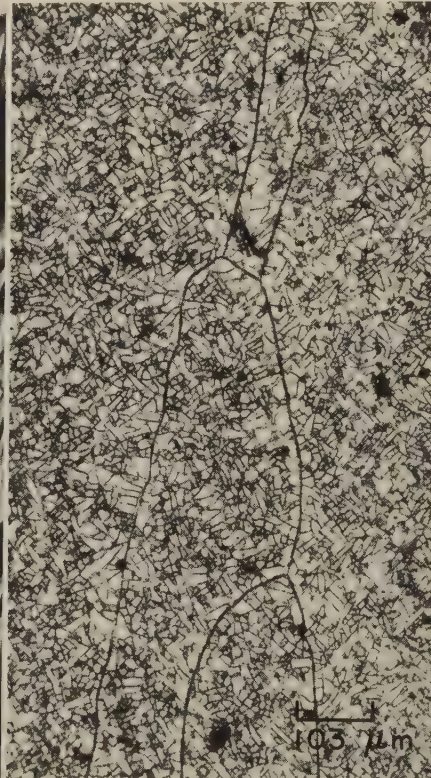
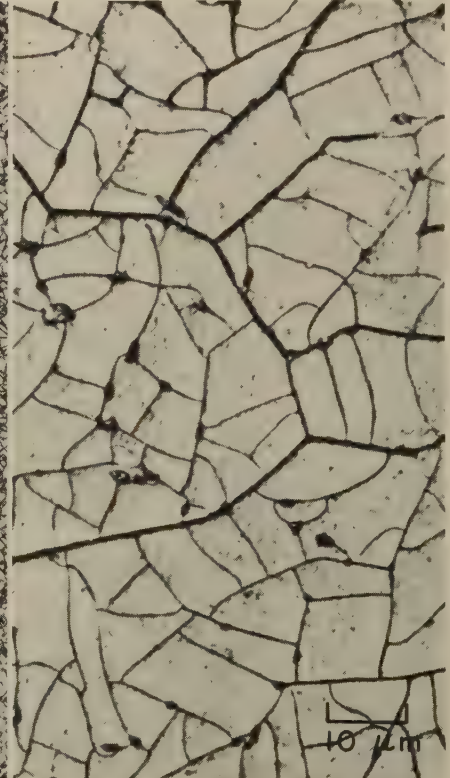
3516, 3517, 3518

Fractograph 3516 (left) is of the surface of an impact fracture in an as-cast specimen of an iron-silicon alloy (0.038% C, 11.84% Si) cast as a 5-lb laboratory ingot and broken by a hammer blow at room temperature, showing a very elaborate surface pattern. The crack front entered this region from upper right, producing markings that are similar to the chevron markings visible in some low-magnification fractographs; markings like those here have also been likened to a "barley shell" etch pattern. The orientations of the diagonal fissures are believed to have been influenced by crystal structure. The microstructure of this specimen, which is shown in micrographs 3517 (center) and 3518 (right), consists of very large ferrite grains containing intricate networks of what may be surface microcracks.

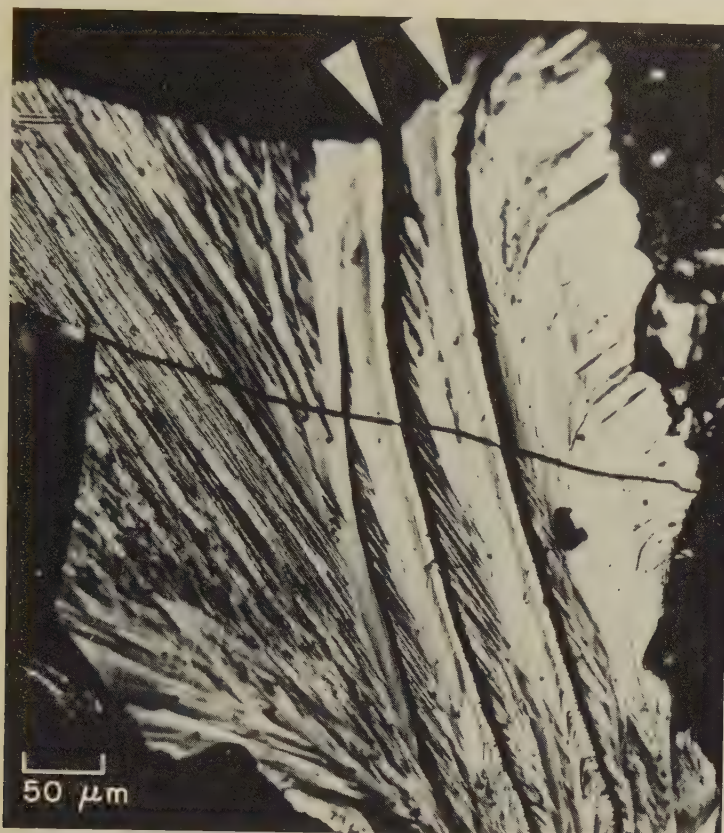
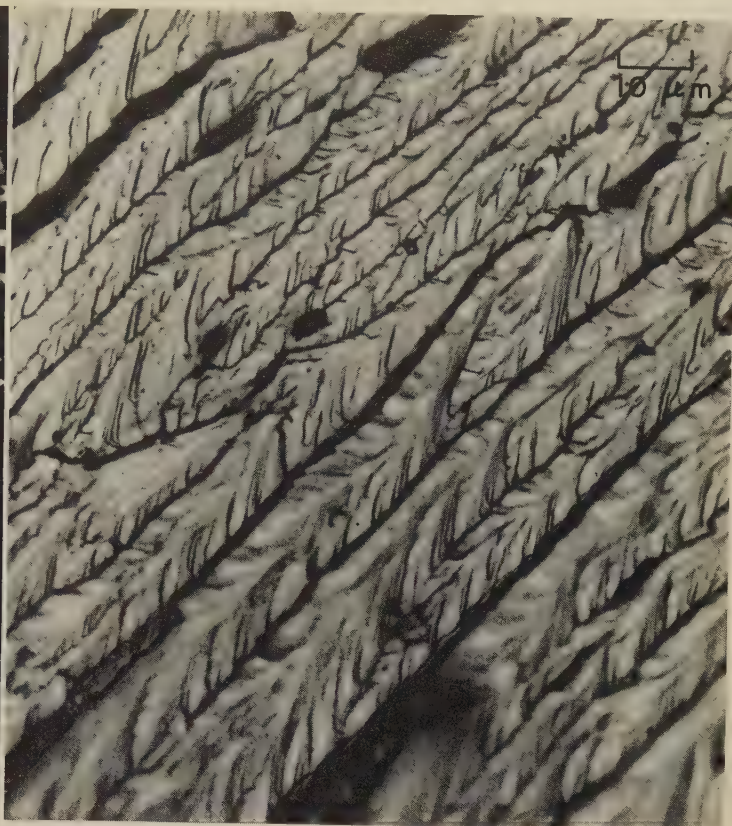
Light fractograph 220× Light fractograph 1090×
3519, 3520 Surfaces of impact fractures in two specimens of the iron-silicon alloy in 3516 (0.038% C, 11.84% Si), also broken at room temperature. Note the very pronounced spines (at arrowheads) in 3519 (left), which are believed to have resulted from the influence of a local multiphase microstructure. The ridge-and-groove fracture markings exhibited in 3520 (right), which are similar to those in 3519, suggest a lamellar microstructure.
